## Accessibility: Example Elbe

## Development of Dredged Material within the Port and the River Elbe in Hamburg 1996 - 2008

# TIDE

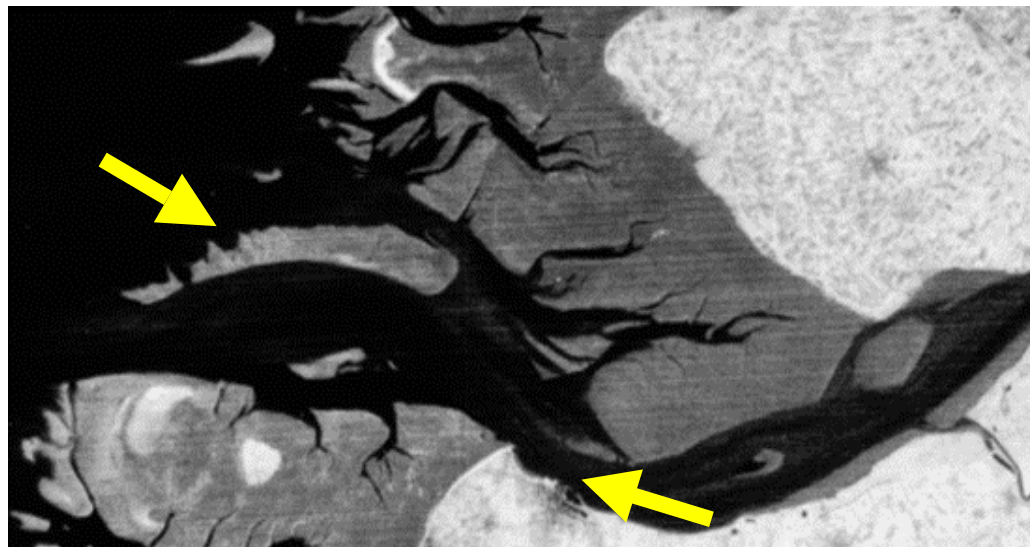
1976

## Morphological development in the estuary

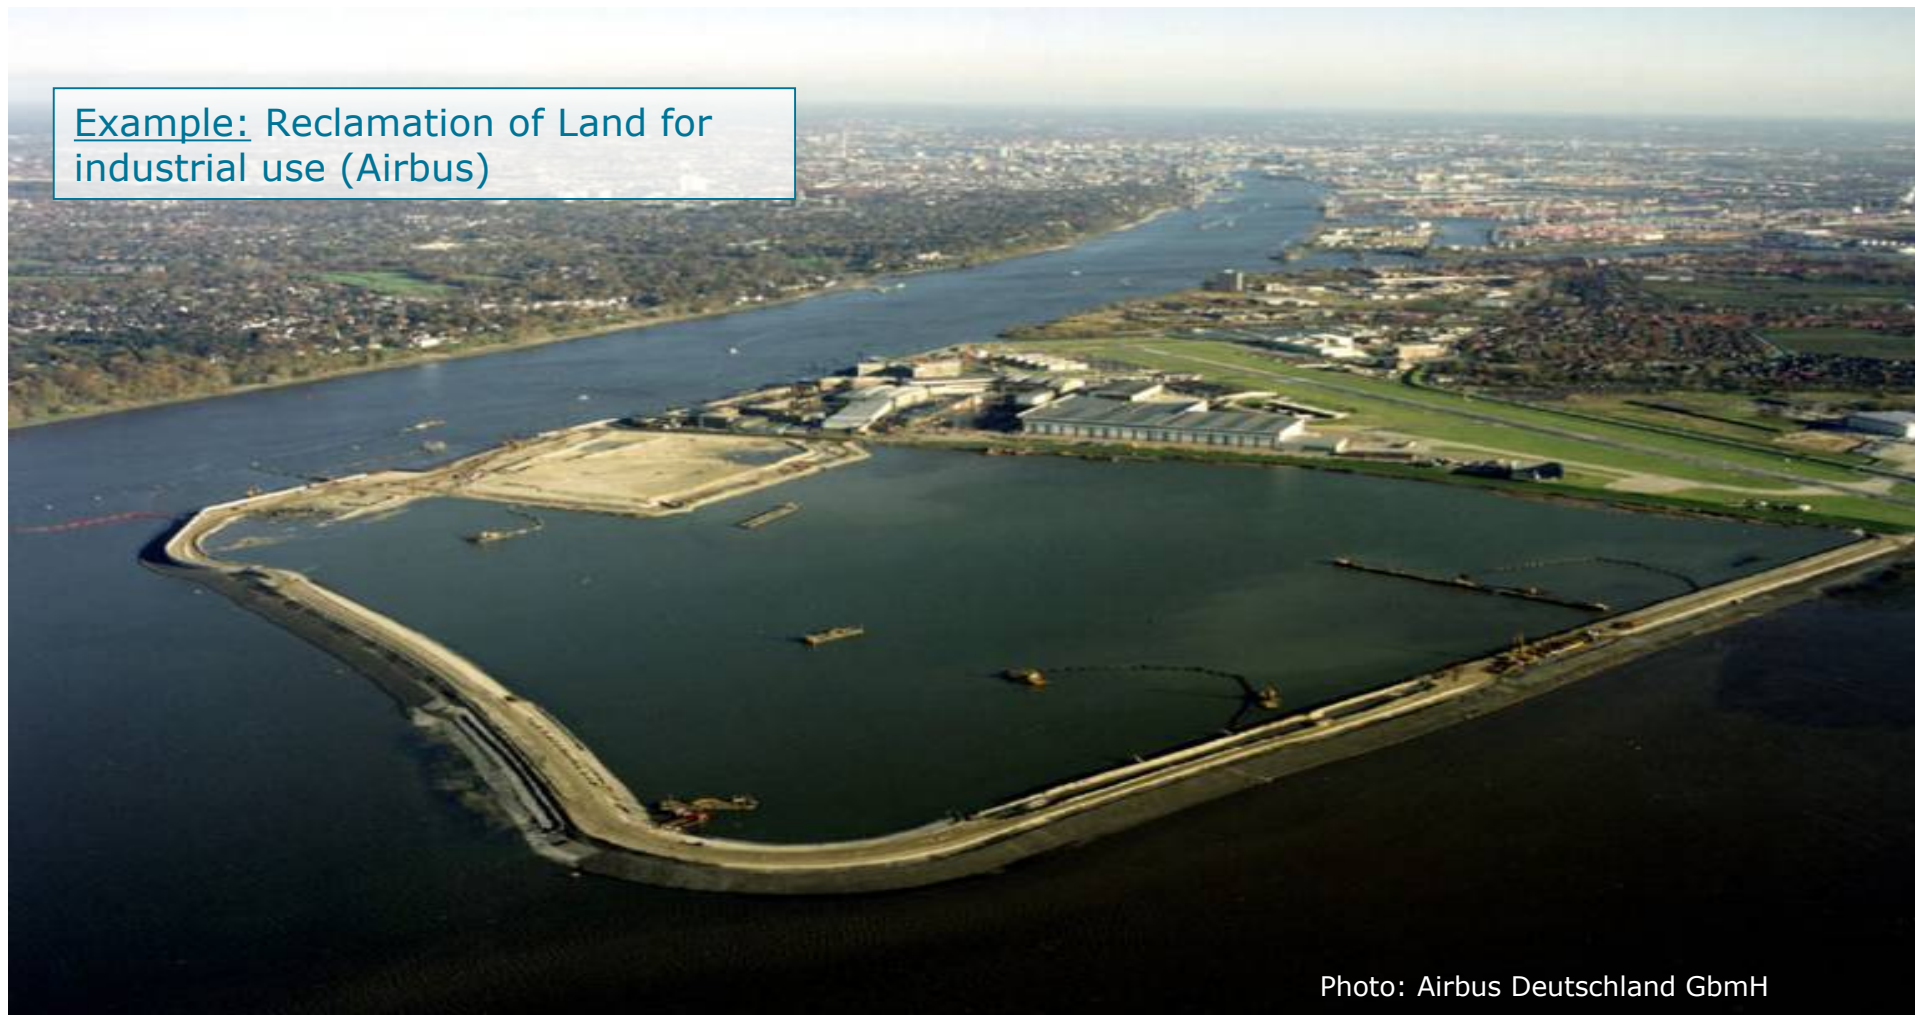
## Loss of shallow water areas in the estuary

Example: Reclamation of Land for industrial use (Airbus)

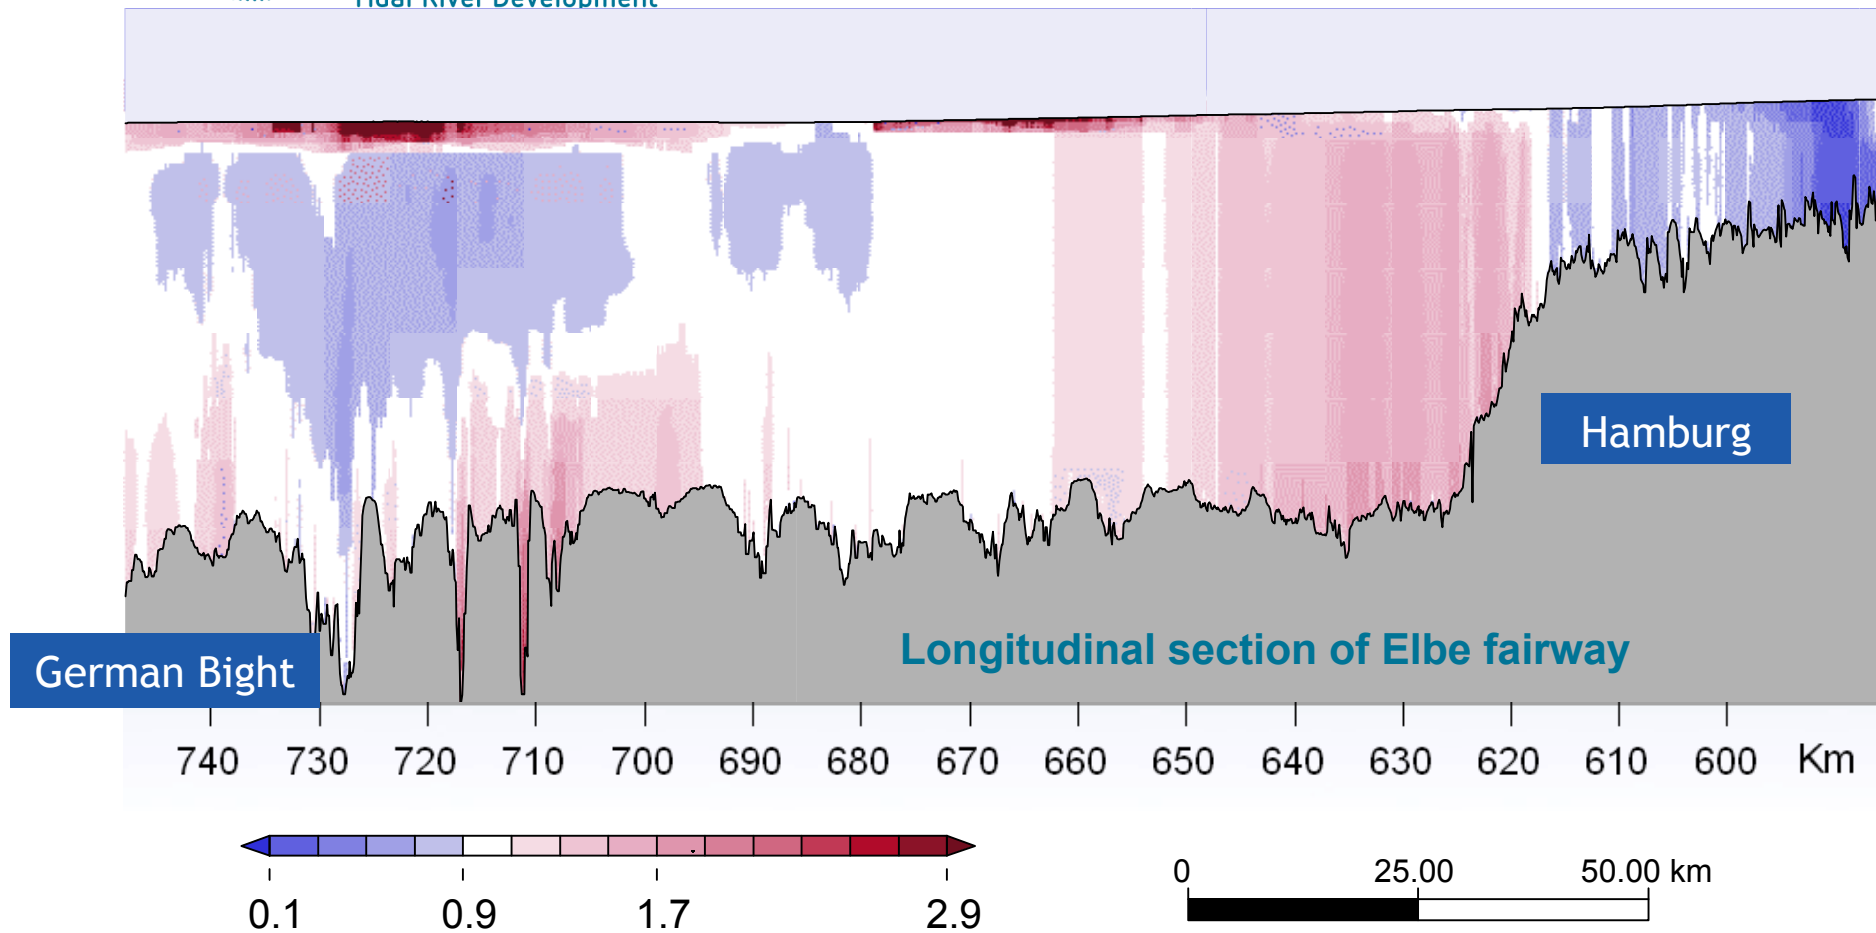
## 3D-Simulation: flood-/ebbcurrent-dominance

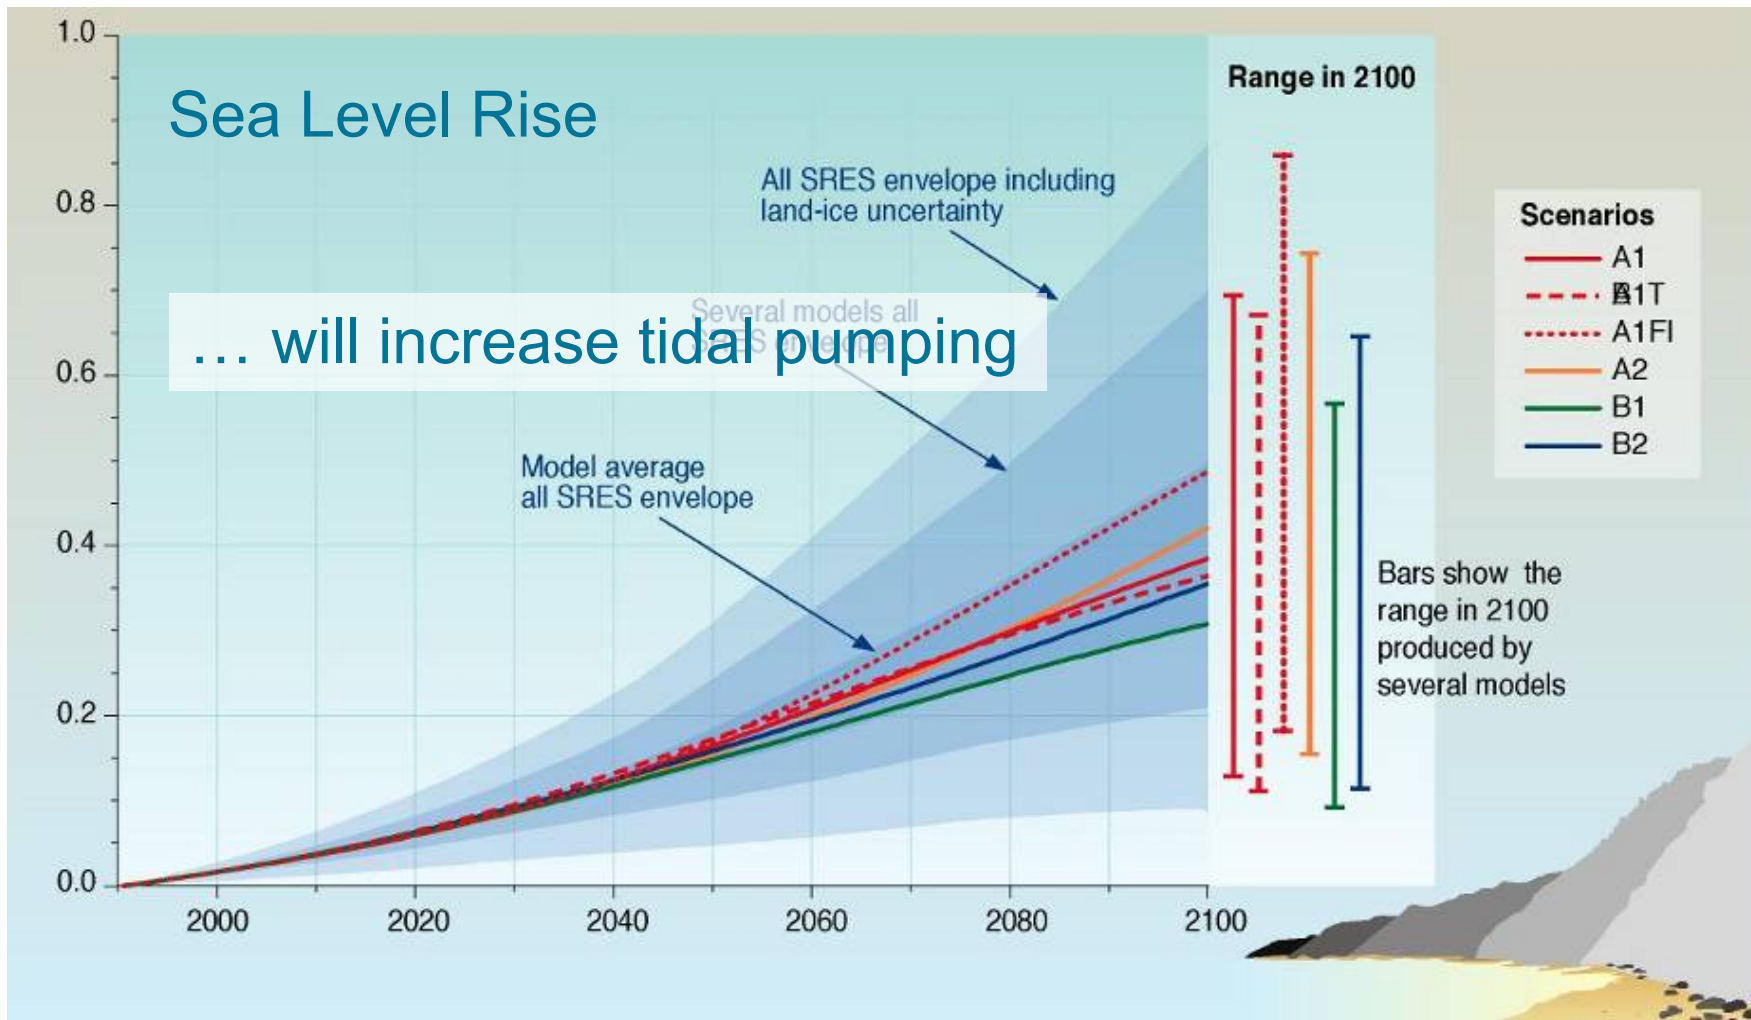
## Effects of Climate Change

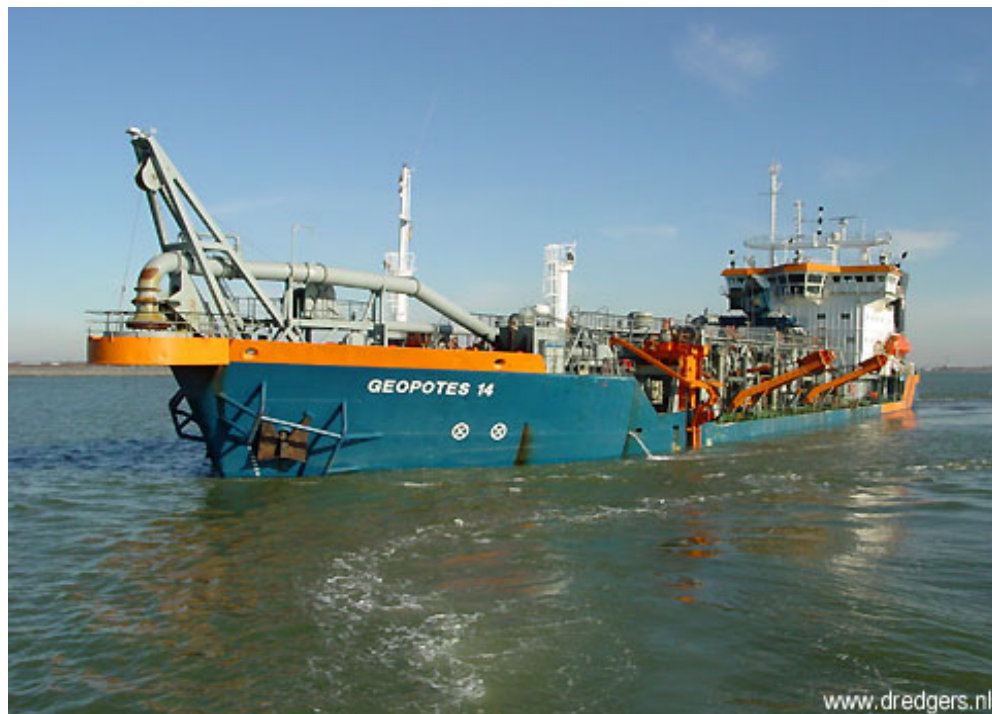
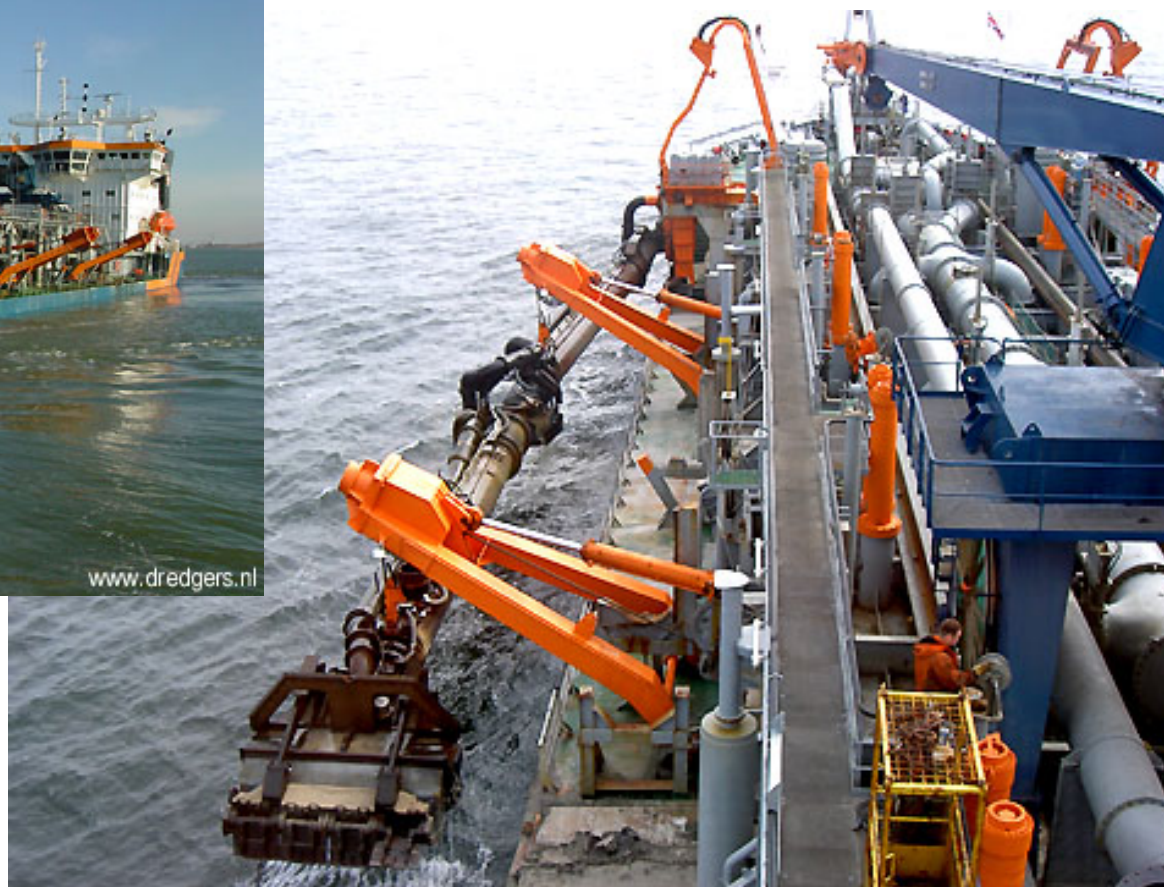
# Adapted Relocation Strategy

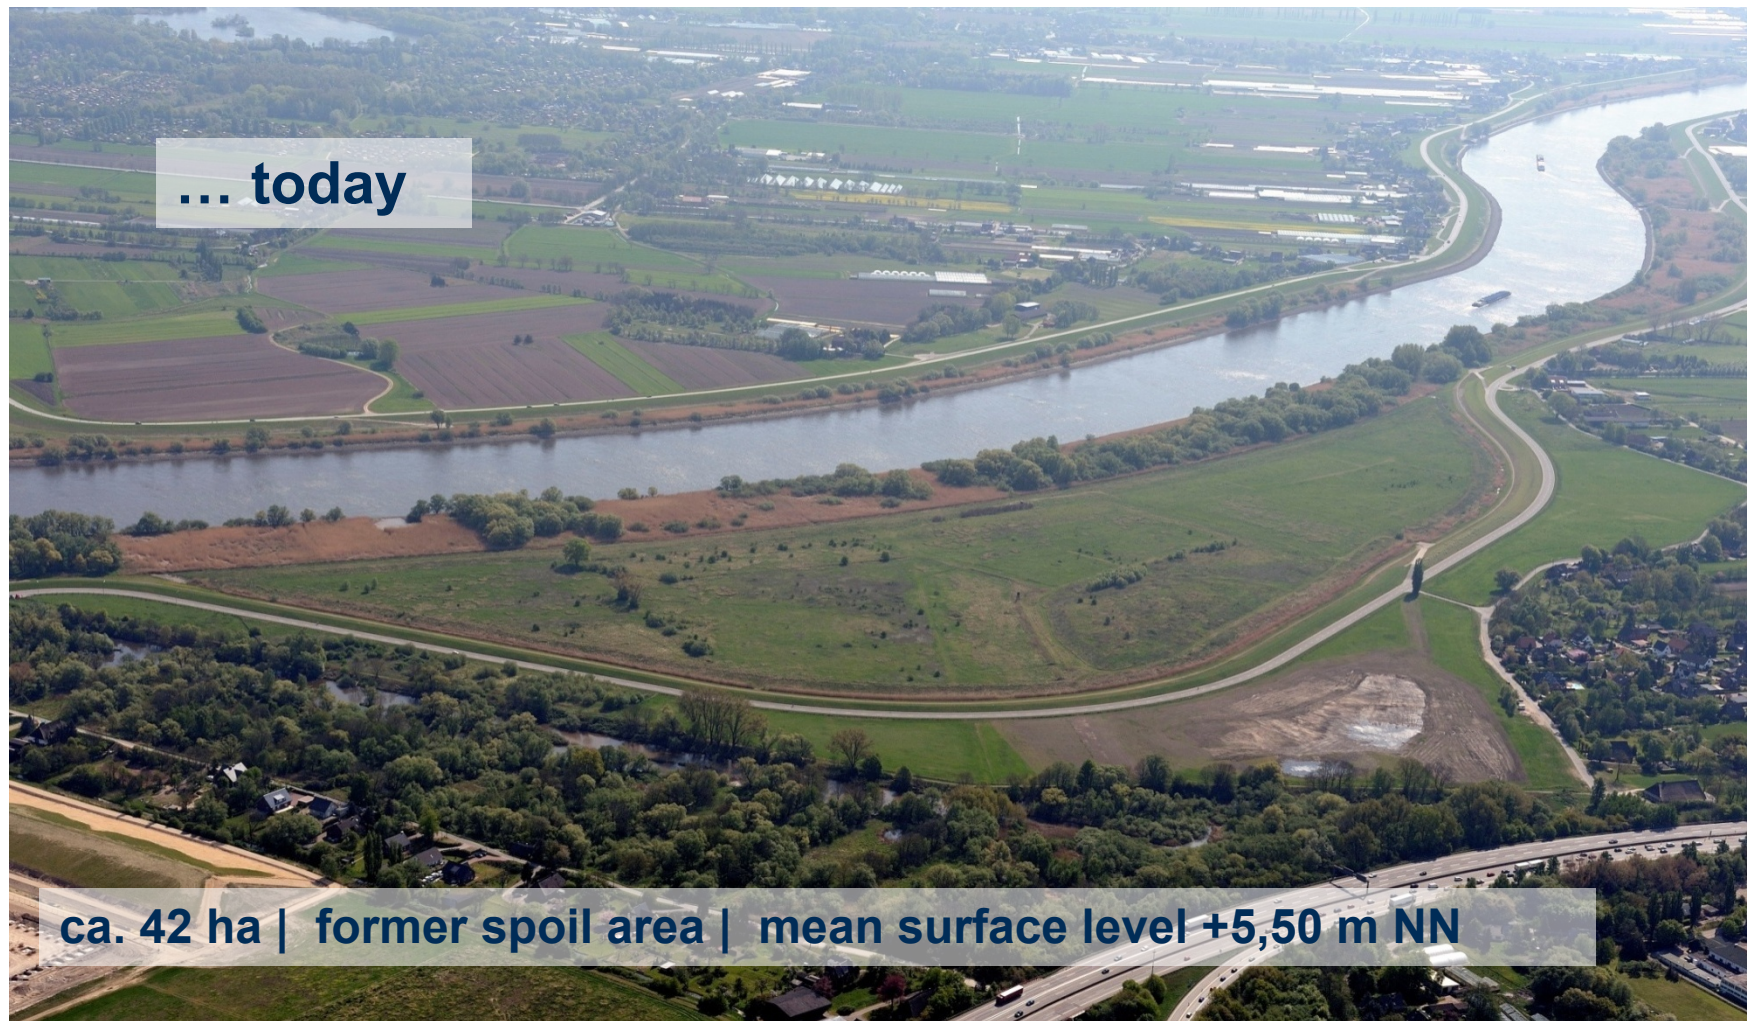
## Pilot project for flooding area

... today

ca. 42 ha | former spoil area | mean surface level +5,50 m NN

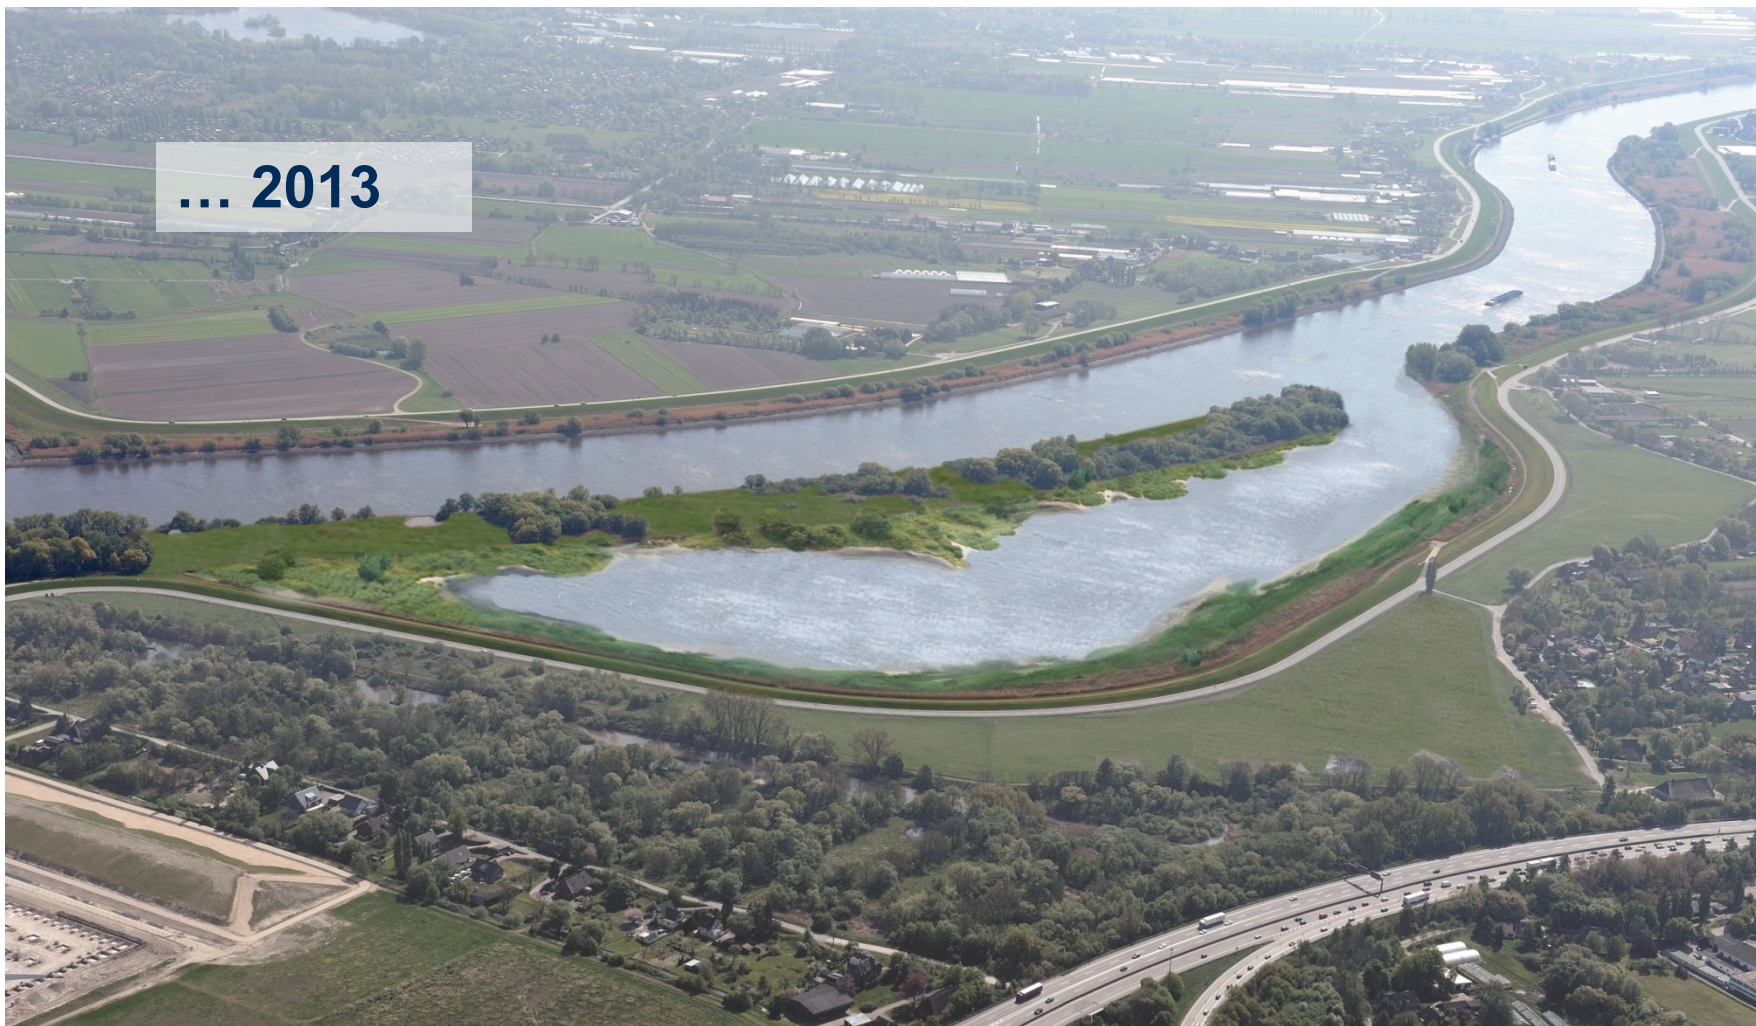
## Pilot project for flooding area
